# DIESEL ENGINE FAILURES DUE TO FUEL WITH INSUFFICIENT LUBRICITY

A.J.von Wielligh, N.D.L.Burger, T.L.Wilcocks

Department Of Mechanical And Aeronautical Engineering  
University of Pretoria  
Pretoria 0002 Republic of South Africa

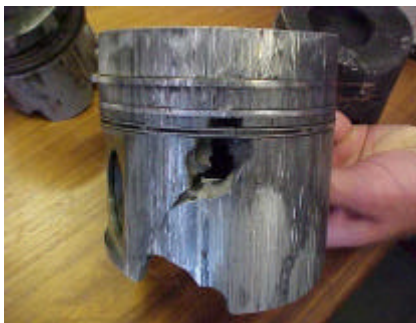
During the regular investigation of engine failures, it was found that a large proportion of engines failed due to the seizing of the piston in the cylinder liner. Very often this happens soon after overhaul. The nature of these failures are that the piston starts seizing on the piston crown and this then gradually works its way down to the skirt of the piston. Several cases were also encountered where the piston crown started melting and in some cases holes were melted through the crown of the piston. Figure 1 and 2, shows the typical type of damage that pistons sustain.

Figure 1: Hole through piston

The damage to these pistons are typical of that of a combustion related failure.

When ever jets of fuel or drops of fuel fall onto the piston crown it starts burning on the material of the piston and overheats this material. In the case of aluminium pistons, the melting temperature of aluminium is soon reached and the material is blown out through the exhaust valve. In severe cases, holes can also be blown through the crown of the piston. Examples of this type of damage is shown in figures 1 and 2.

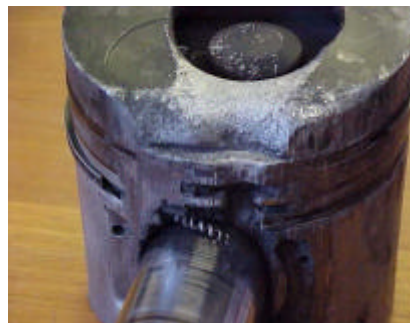
Figure 2: Melted piston crown

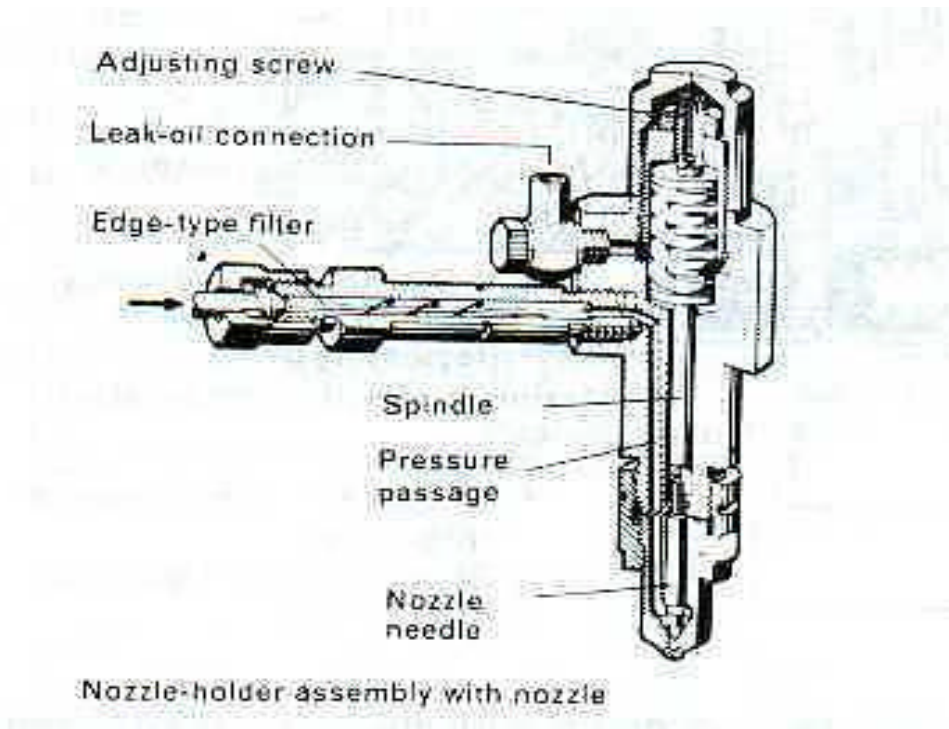
The injected fuel is broken up in a very fine spray and the combustion process starts by oxidizing the fuel droplets from the surface of these drops. It must furthermore be kept in mind that the smaller the droplets, the bigger the specific area, which means that combustion takes place faster and more efficiently. There is therefore a tendency towards smaller droplets and finer spray in the higher pressure modern diesel engines. The spray is obtained by supplying fuel to the needle which is in the closed position and held down by a spring. When the pressure has built up sufficiently, the spring force is overcome and the needle is lifted from the seat. At this point in time a very high pressure exists around the needle. This high pressure then forces diesel through the orifices of the injector tip and a very fine spray is obtained. The layout of an injector is shown in figure 7.

Figure 7: Injector layout

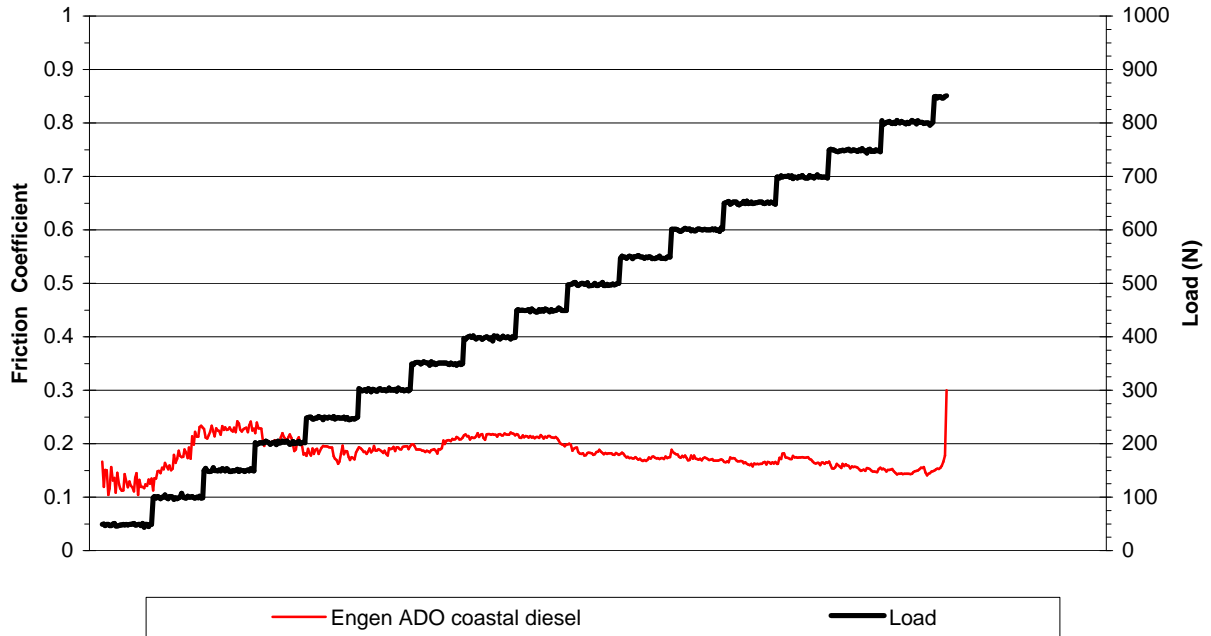
Graph 1

5.1 As mentioned above it was necessary to establish a base line for reference purposes. For this purpose coastal diesel was tested. The result of this test is shown in graph 1 in the Annexure.

**Engen ADO Coastal Diesel**

**Ultimate Load Test:** Run at 110 degrees C, frequency 50 Hz, stroke length 1mm with 50 N increments of 1 min duration each.  
Break-through coefficient set at 0.3

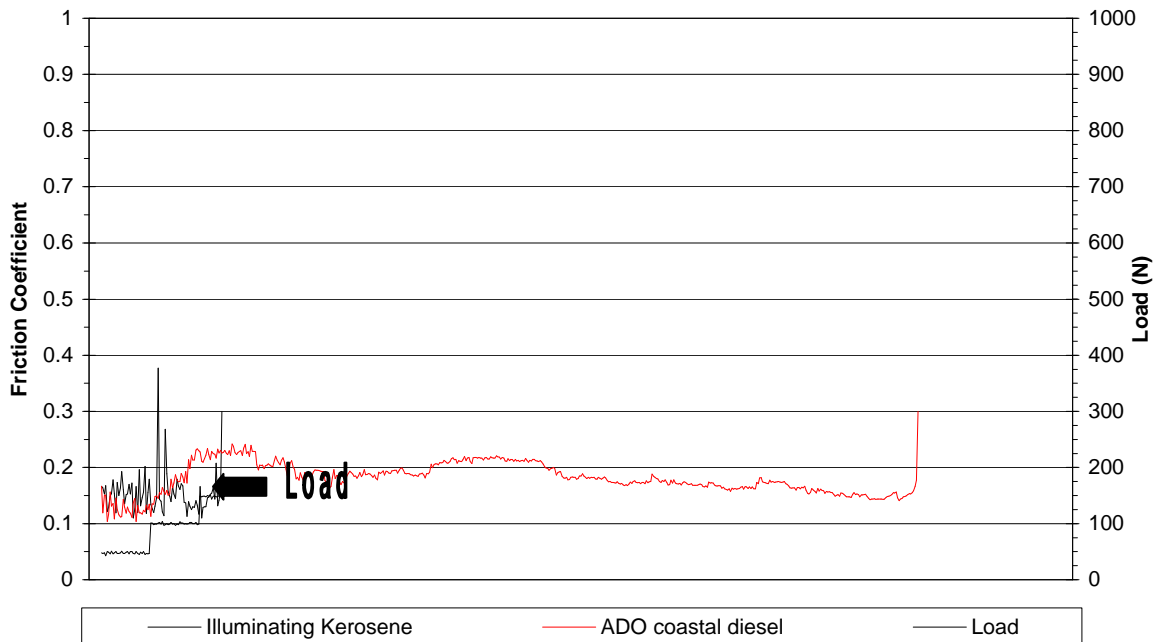
Graph 2

As a comparison illuminating paraffin and jet fuel were also tested. The results of these tests are shown graphs 2 and 3 in the Annexure. This was done, because it is known that some diesel distributors are adding kerosene or jet fuel to diesel, to make more profit.

**Illuminating Kerosene**

**Ultimate Load Test:** Run at 110 degrees C, frequency 50 Hz, stroke length 1mm with 50 N increments of 1 min duration each.  
Break-through coefficient set at 0.3

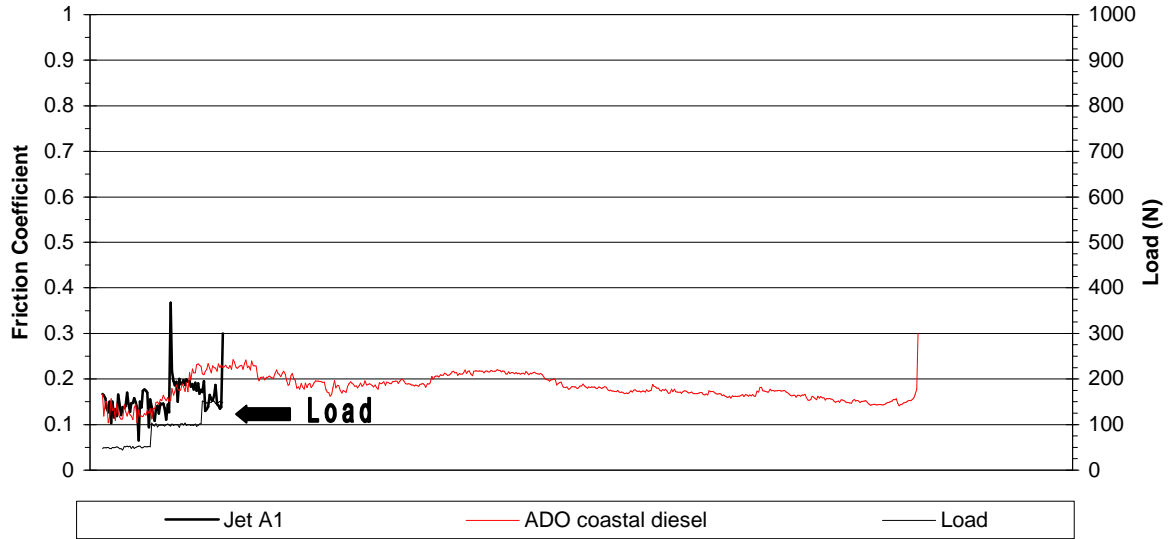
Graph 3

### Jet A1 (Aviation Kerosene)

Ultimate Load Test: Run at 110 degrees C, frequency 50 Hz, stroke length 1mm  
with 50 N increments of 1 min duration each.  
Break-through coefficient set at 0.3

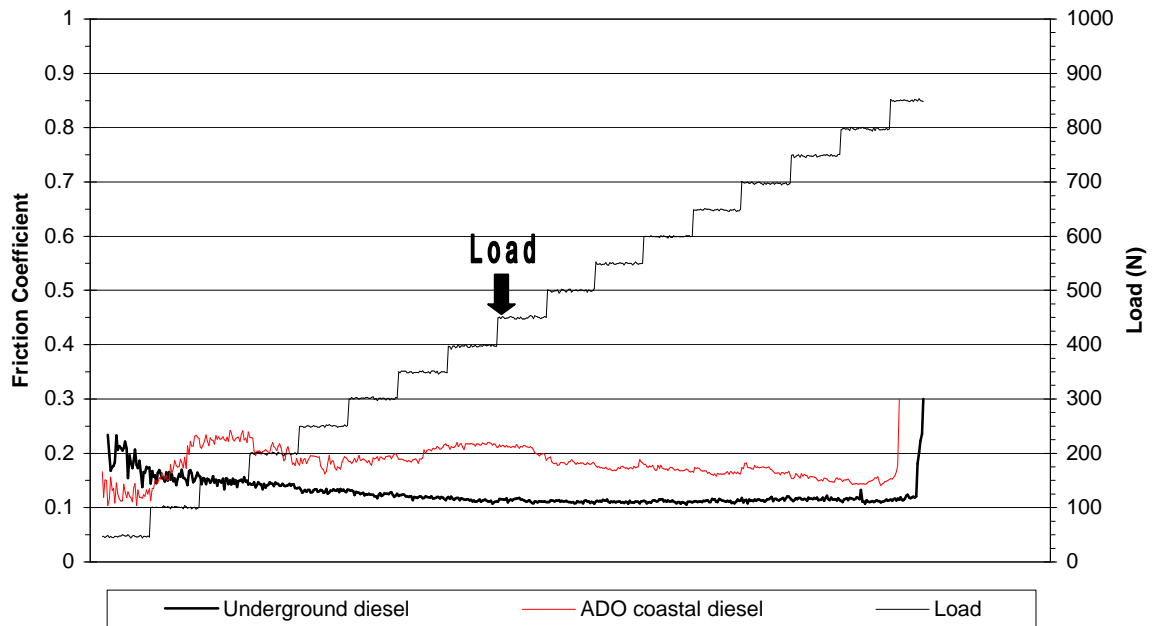
Graph 4

5.2 Several of the South African mines make use of a so called "Underground Diesel", to reduce air pollution of diesel engines in confined spaces. This underground diesel is basically kerosene with a proper additive. From a mine where no problems with sticking diesel injectors are experienced, samples were obtained and these were tested. The results of these tests are shown in graphs 4 and 5 in the annexure. It can be seen that this fuel passes the parameters and limits that were decided upon initially.

### Underground Diesel

Ultimate Load Test: Run at 110 degrees C, frequency 50 Hz, stroke length 1mm  
with 50 N increments of 1 min duration each.  
Break-through coefficient set at 0.3

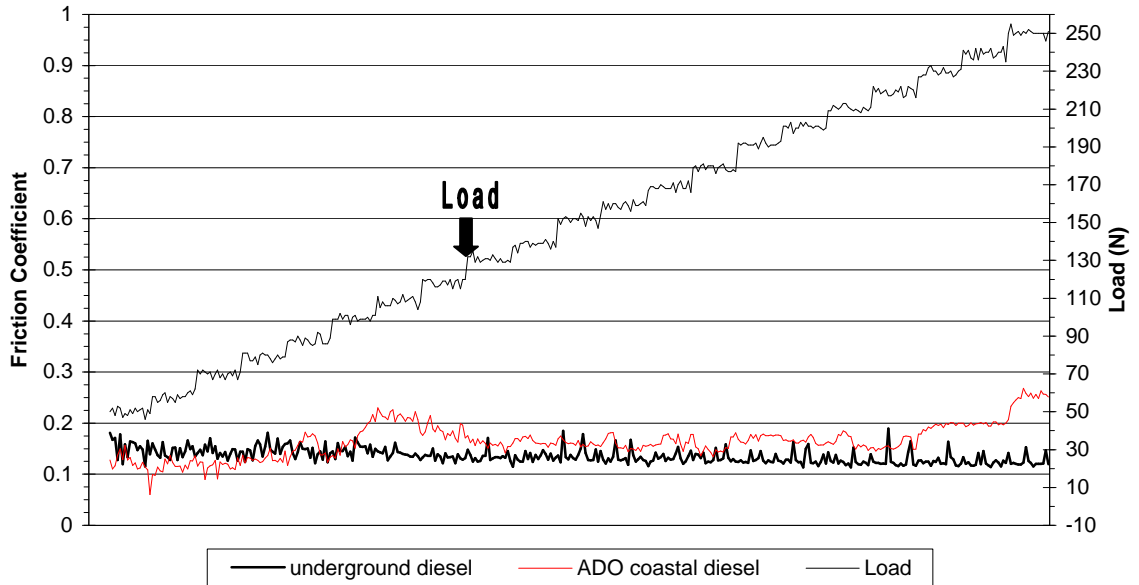
Graph 5

### Underground Diesel

**Injector Simulation Test:** Run at 110 degrees C, frequency 50 Hz, stroke length of 1 mm with 10 N increments of 30 sec duration each.

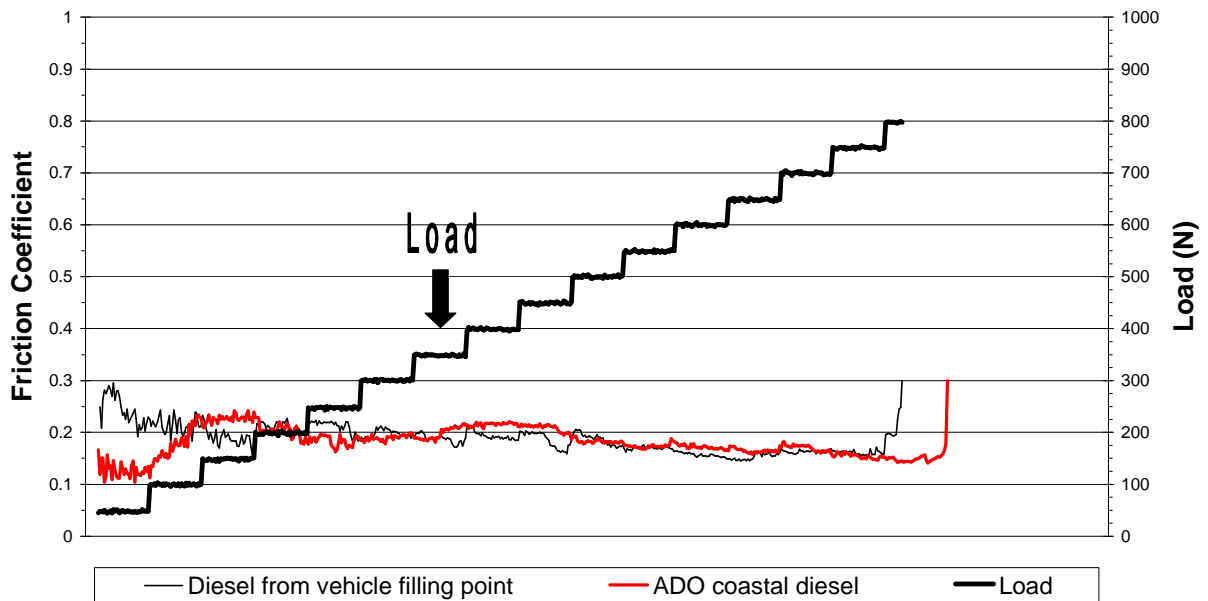
Graph 7

5.3 When the failure of a 5 cylinder diesel engine from a vehicle was investigated, it was found that the Bosch injection pump failed due to the fact that the plunger seized and twisted off. Diesel was extracted from the tank of this vehicle and tested. The results of this test are shown in graph 6 in the annexure. As can be seen from the graphs, the fuel does not meet the limits set for proper lubricity properties. As part of the investigation fuel was obtained from the point where the vehicle allegedly filled its tank, 200km before the failure. This fuel was tested and the results can be seen on graph 7 in the annexure. This fuel clearly passes the test indicating that the driver most probably added kerosene at a lower price to put the extra money in his pocket.

### Diesel from Vehicle Filling Point

Ultimate Load Test: Run at 110 degrees C, frequency 50 Hz, stroke length 1mm  
with 50 N increments of 1 min duration each.  
Break-through coefficient set at 0.3

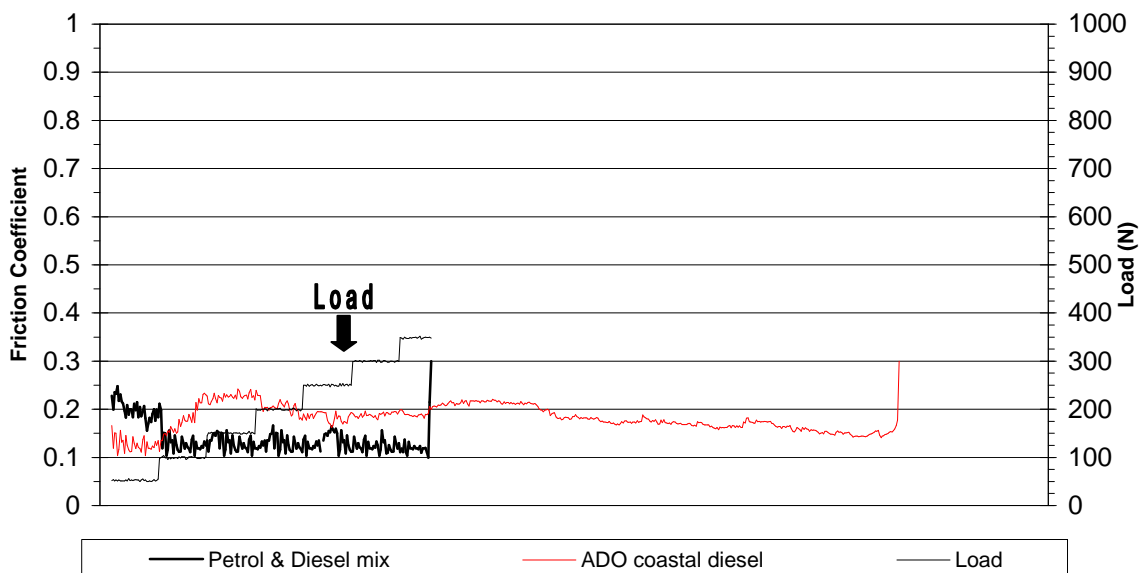
Graph 8

5.4 During the investigation of another engine failure, it was established that when the customer ordered bulk supplies of diesel fuel, the fuel that was delivered to him was mixed with petrol. The petrol contamination in some cases were as high as 25%. Several of the engines of this contractor failed, amongst others a small 4 cylinder Japanese diesel vehicle. This particular vehicle was only in service for about 2 000km since a complete engine rebuilt. When the failed engine was stripped, it was found that scuffing of the piston crowns had occurred and that the pistons started seizing in the cylinder liner. The injectors were carefully removed and tested. The spray pattern obtained is shown in figure 3. When the injector needles were removed, it was found that the tips of the needles were badly discoloured and when the needles were investigated under the microscope it was found that the shank of the needles were scuffed as indicated in figure 6. These injectors were replaced as new and genuine when the engine was rebuilt. The fuel was then taken and tested on the SRV machine and the results are shown in graph 8 in the annexure. As can be seen the fuel failed the tests long before the minimum load carrying capacity was reached.

### Petrol and Diesel Mixture

Ultimate Load Test: Run at 110 degrees C, frequency 50 Hz, stroke length 1mm  
with 50 N increments of 1 min duration each.  
Break-through coefficient set at 0.3

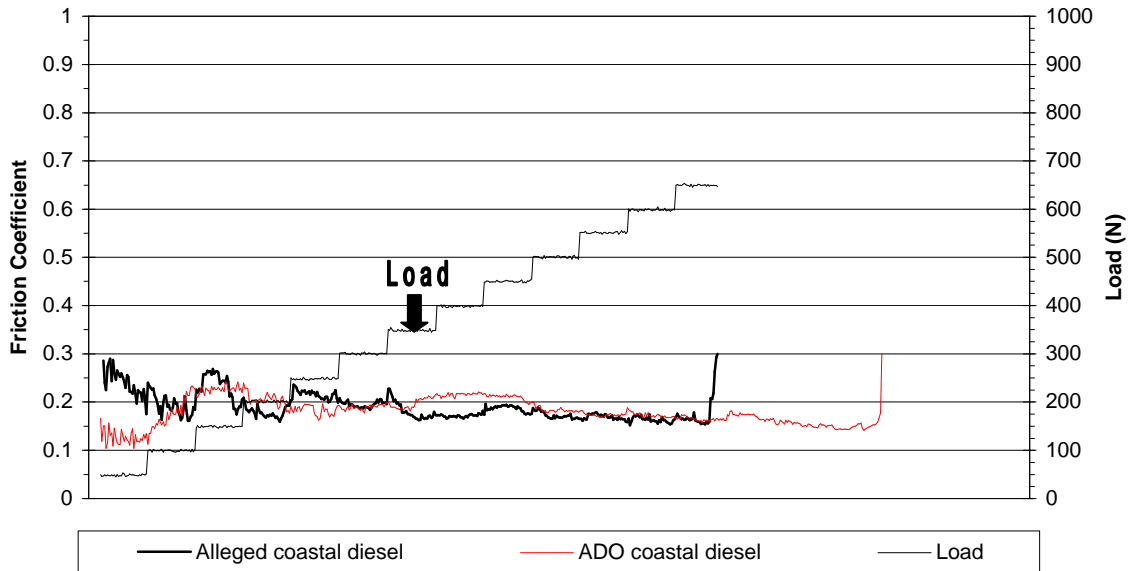
Chart 9

5.5 After receiving several complaints about engines failing, when used on fuel from a particular independent distributor, samples were obtained from this distributor. This distributor alleges that he was supplying coastal diesel, although his operation was in the North West Province of this country. The results of this alleged coastal diesel is shown in graph 9 in the annexure. This fuel was tested against the normal SABS 342 specification and complied with this specification. The viscosity was however at the bottom limit of the allowable viscosity. As can be seen this fuel did not pass the test and it is considered that this distributor is blending in kerosene with coastal diesel in such a way that it still satisfies the normal SABS 342 specification, but the fuel has very poor lubricating properties causing engine failures.

### Alleged Coastal Diesel Sample from an Independent Source

Ultimate Load Test: Run at 110 degrees C, frequency 50 Hz, stroke length 1mm  
with 50 N increments of 1 min duration each.  
Break-through coefficient set at 0.3

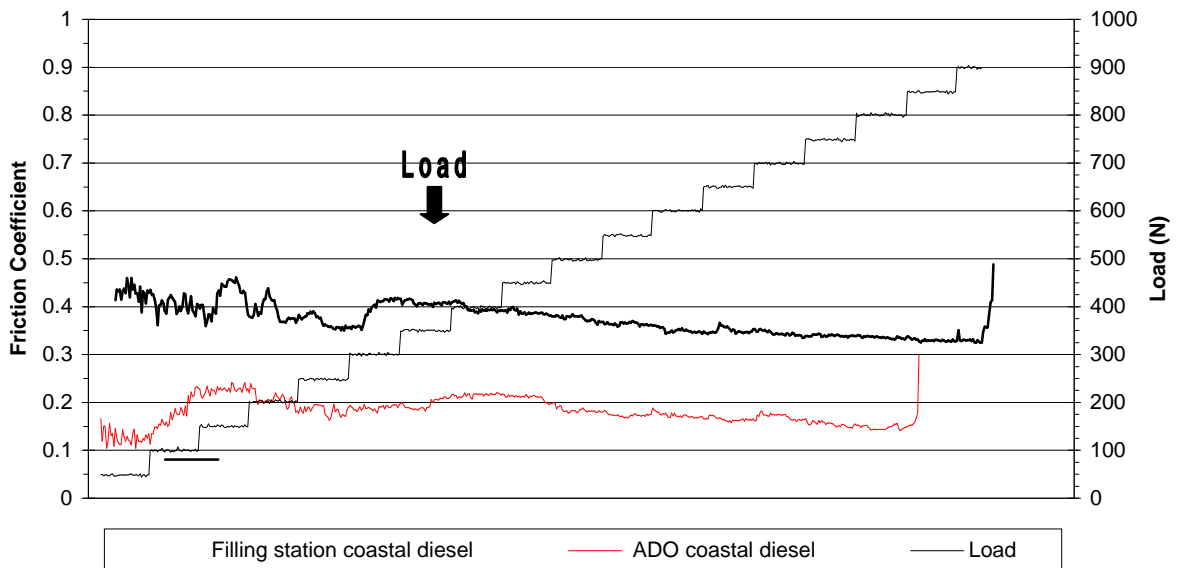
Chart 10

5.6 As another comparison, fuel was bought at a filling station in Durban and the results of this test are shown in graph 10 in the annexure. It can be seen that this fuel passes the test with flying colours.

### Coastal Diesel from a Durban Filling Station

Ultimate Load Test: Run at 110 degrees C, frequency 50 Hz, stroke length 1mm  
with 50 N increments of 1 min duration each.  
Break-through coefficient set at 0.3

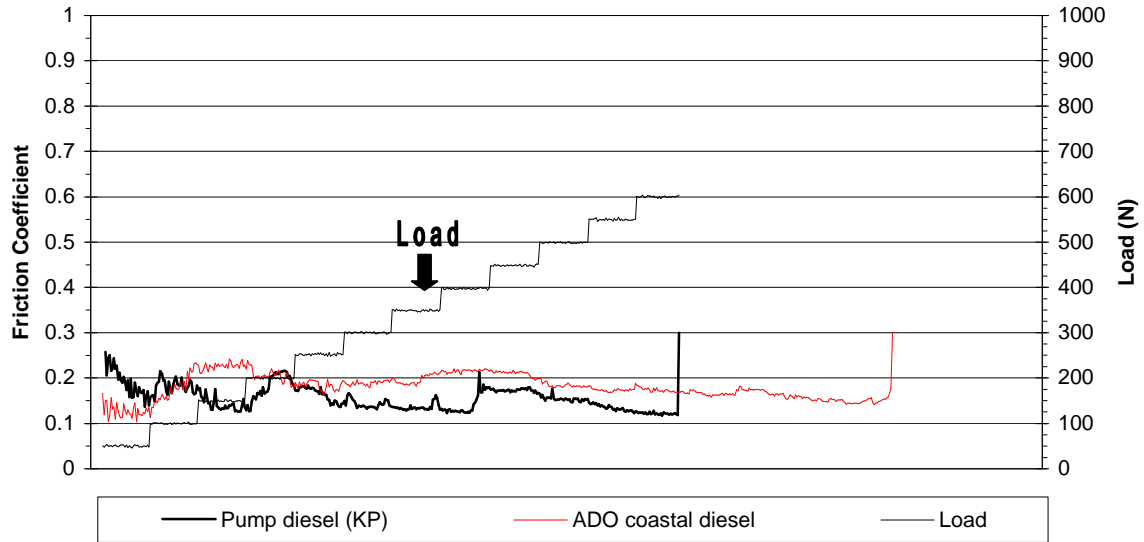
Graph 11

Fuel was bought from a filling station in the Kempton Park area, and was tested on the SRV machine giving the result as shown in graph 11 in the annexure. As can be seen in the graph this fuel does not satisfy the requirements of this test and vehicles making use of this fuel are therefore under a threat of failure.

### Pump Diesel (Kempton Park)

**Ultimate Load Test:** Run at 110 degrees C, frequency 50 Hz, stroke length 1mm  
with 50 N increments of 1 min duration each.  
Break-through coefficient set at 0.3

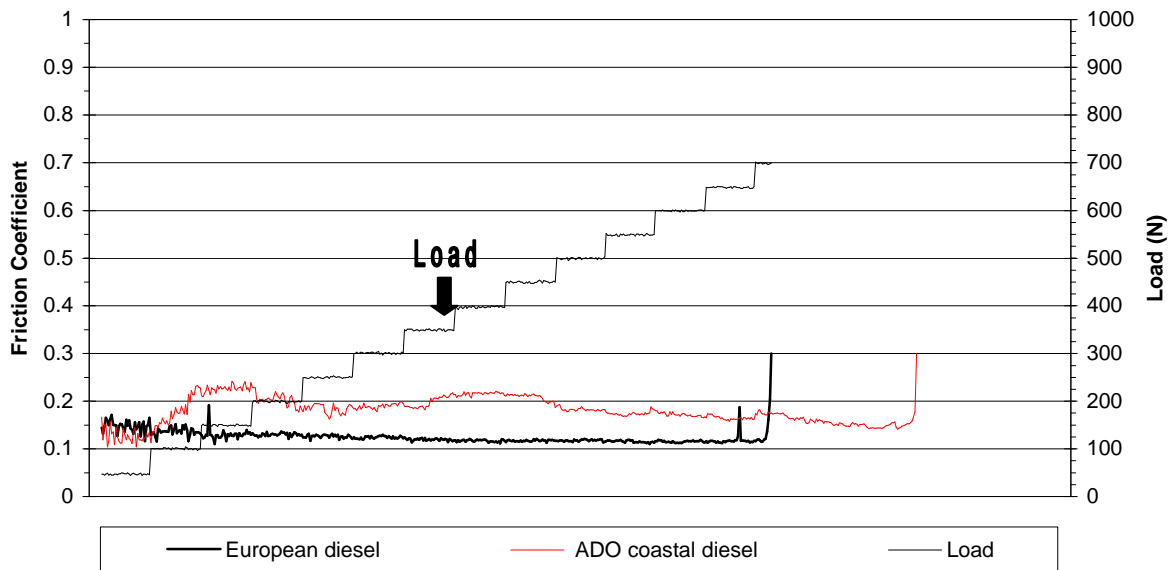
Graph 12

Finally a sample of diesel from Belgium was obtained and tested and the results of this fuel are shown in graph 12 in the annexure. The fuel passes the test with flying colours, but it is important to note that the friction co-efficient line lies even lower than the reference line of South African coastal refined diesel.

### European Diesel

**Ultimate Load Test:** Run at 110 degrees C, frequency 50 Hz, stroke length 1mm  
with 50 N increments of 1 min duration each.  
Break-through coefficient set at 0.3
